# FILTERCAKE ANALYSIS

## CENTRIFUGAL OIL FILTRATION – SOS15

# SOS15 FILTERCAKE ANALYSIS

CENTRIFUGAL OIL FILTRATION (COF) NON-CAT ROTOR SAMPLING INSTRUCTION

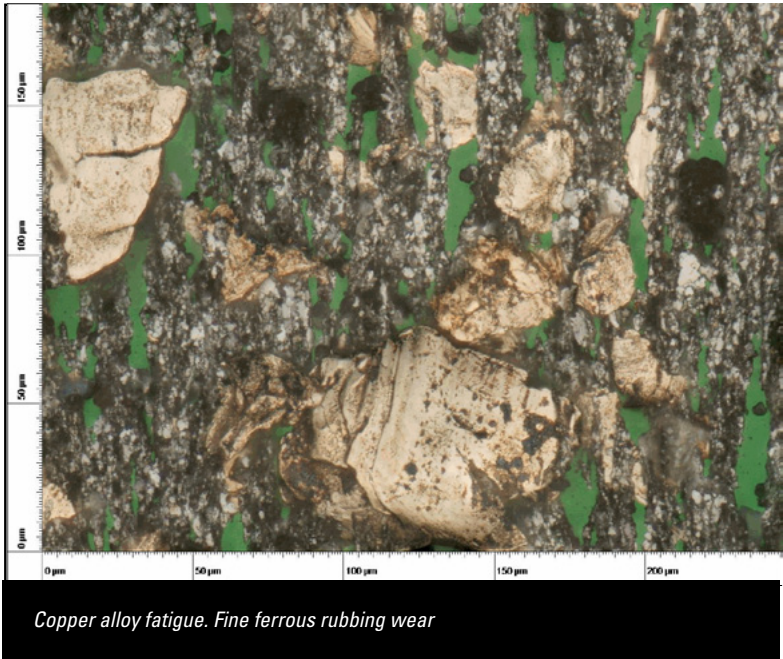
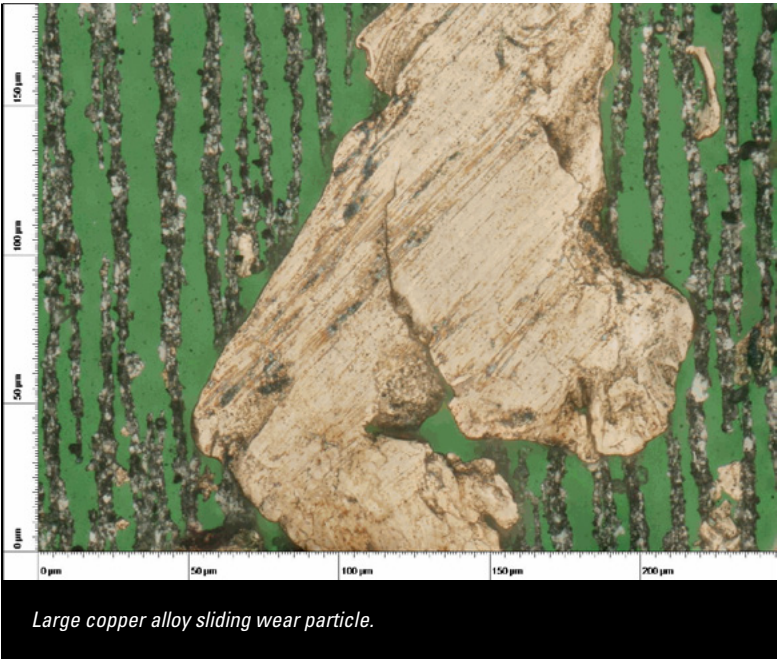
LCN 16074401 EVALUATION X

Note the oil sample above with a history of A samples and no indicators of trouble. However the wear debris images below show a different story, this engine was in advancing stages of distress however the material was being removed and deposited within the COF.

CASE STUDY 1  
FILTERGRAM REPORT : QSK78 - COF
